Monitoring of Spanish Landfill sealings by Leakdetection and –location systems – An Example for European high standards in environmental protection and lining technology?

Michael Arndt, GEOLOGGER SYSTEMS GmbH, Großbeeren, Germany
Mario Garcia-Girones, TERRATEST S.A., Madrid, Spain

Monitoring of Landfill sealings by Leak-detection and –location systems

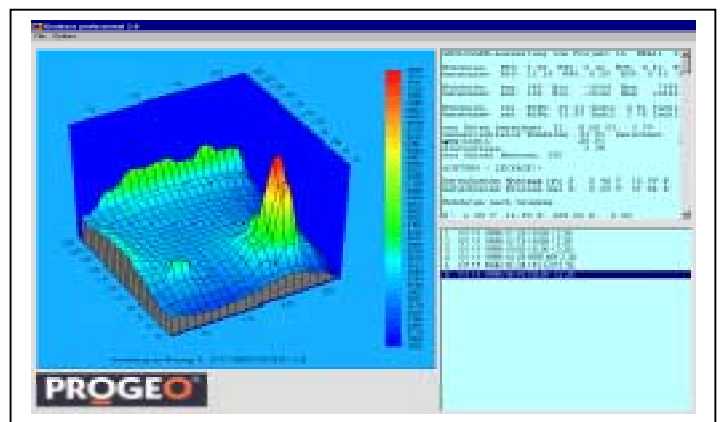
The results of a measuring are visualized by a special Evaluation Software delivered by PROGEO

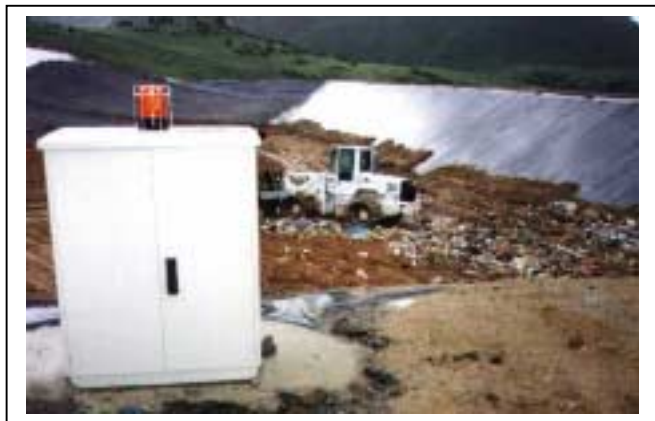
The landfill La Cerdanya is situated on the slopes of the pyrenees, next to the towns Belver de Cerdanya and Puigcerda. It is a new landfill founded in 1998 with a planned maximum capacity of 500.000m³ municipal waste. The total area of the landfill base will be 50.000m². In 1998 the works for the Base Sealing System began for the first construction part on an area of approx. 10.000m². The landfill lies on the slope of a mountain. During the excavation works three walls were built around the landfill. The wall slopes are steep, approx. 45 degrees. The construction company and future operator of the landfill was ROMA, Lleida. The installation of the liner was performed by TERRATEST GROUP, Madrid.

The measuring system contain approx. 400 measuring points connected by 16 connection wires to the control box. The system is set up as an online version for continuous measurements and is generated by solar energy. Datatransmission is carried out by modem. The system has a warranty of 4 years.

Several leaks were detected and located during the first measurements in November 1998. All leaks were caused by installation works. The size of the leaks varied from 5 mm up to over 1m. The geometry differed in relation to the situation that caused the leak between round and indefinite. Size, geometry and the position of the leaks allowed in most cases a detailed reconstruction of the situation which consequently led to the reason how the liner was penetrated: Stones being pressed through the liner, as well as knife-cuts, incorrect weldings or big damages caused by bulldozers or trucks during the phase of distributing the sand upon the liner. Bearing this in mind it is remarkable to note that the biggest leak in that project lay quite close to the lowest point of the sealing right next to the main collecting drainage tube. A leak like that, remaining undetected would have weakened the stability of the wall extraordinarily over the years. The detection of that single leak already amortized the investment in the monitoring system.

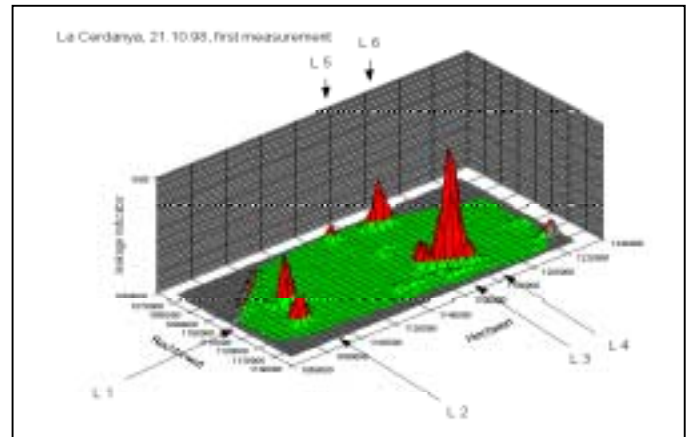
After the installation of a 1m mineral layer, the measuring electrodes were installed in a distance of 5m x 5m and then covered by a 1,5mm

HDPE liner. Three active electrodes were fixed upon the liner, then the liner was covered by a 10cm sand layer for protection. After the covering of the liner was completed the measurements could start.

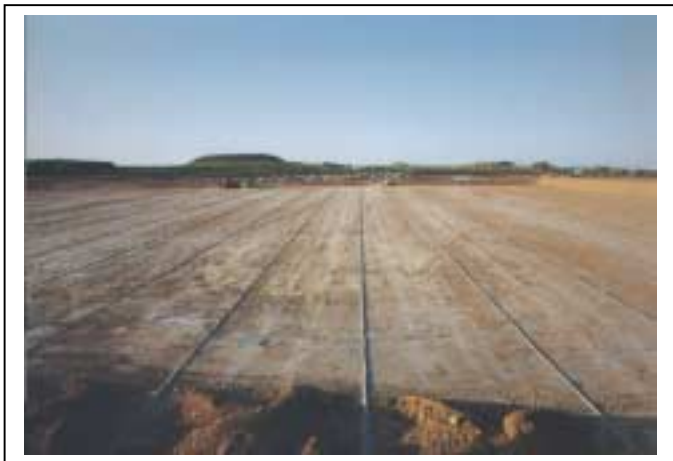
The landfill Montoliu is the new central landfill for the region around Lerida. The size of the base liner sealing system is approx. 34.000m². The construction began in August 1999 and was completed in December 1999. The topographic situation is flat and the geometric form is rectangular. The landfill is surrounded by four walls with a slope angle of approx. 45 degrees. The construction company was the company FCC, Madrid, the installation of the liner was performed by TERRATEST GROUP, Madrid.

The measuring system contain approx. 1000 measuring points connected by 48 connection wires to the control box. The system is built as an offline version for periodic measurements. The warranty of the electrodes is 1 year for the first half of the area and 3 years for the second half. After the installation of a 1m mineral layer, the measuring electrodes were installed in a distance of 5m x 5m and then covered by a 1,5mm HDPE liner. Eight active electrodes were fixed upon the liner, then the liner was covered by a 300gr/m² geotextile as protection layer and then with 50cm of gravel.

The installation of the lower GEOLOGGER electrodes was optimized. Instead of digging the cables into the mineral layer in a defined depth of 2cm, the electrodes were layed upon the mineral sealing and covered with a sand line to prevent the liner from mechanical stresses. Consequently the daily installation progress could be augmented up to 8.000m² per day.

After the covering of the liner was completed, the measurements could start. Several leaks were detected and located during the first measurements in December 1999. All leaks were caused by installation works. The size of the leaks varied from less then 1mm up to over 1,5 m. The geometry differed in relation to the situation that caused the leak between round and indefinite. In most cases the reason for the damages

could be reconstructed. The distribution of the gravel above the liner was performed by bulldozers. The installation of the drainage pipes into the gravel layer partly was carried out with heavy machines. The overwhelming part of the leakages were caused by stones being pressed through the liner. The required forces were delivered in some cases by the great weight of the used machines, in other cases high wheel forces of pulling machines led to big damages in the liner.

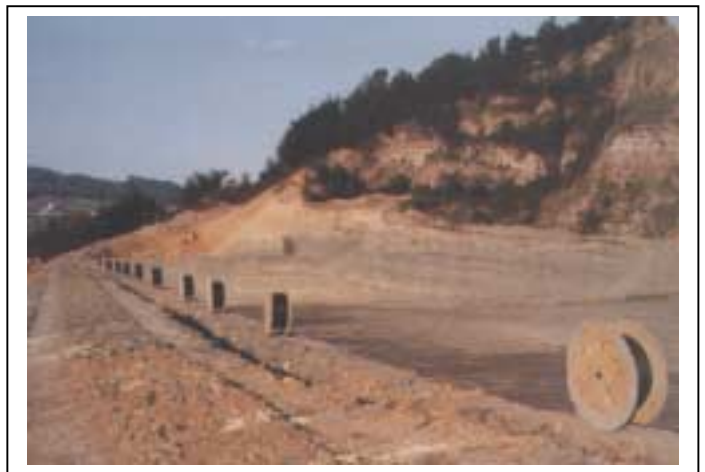
The measuring system contain approx. 600 measuring points connected by 31 connection wires to the control box. The system is built as an online version for continuous measurements. Datatransmission is carried out by e-mail and modem. The system has a warranty of 5 years. After the installation of a 1m mineral layer, the measuring electrodes were installed in a distance of 6m x 6m and then covered by a 400gr/m² geotextile followed by a 2 mm HDPE liner. Six active electrodes were fixed upon the liner, then the liner was covered by industrial sand.
